A clinical protocol for analysis of the structural integrity of the Medtronic CoreValve System® frame and its application in patients with 1-year minimum follow-up

Abstract

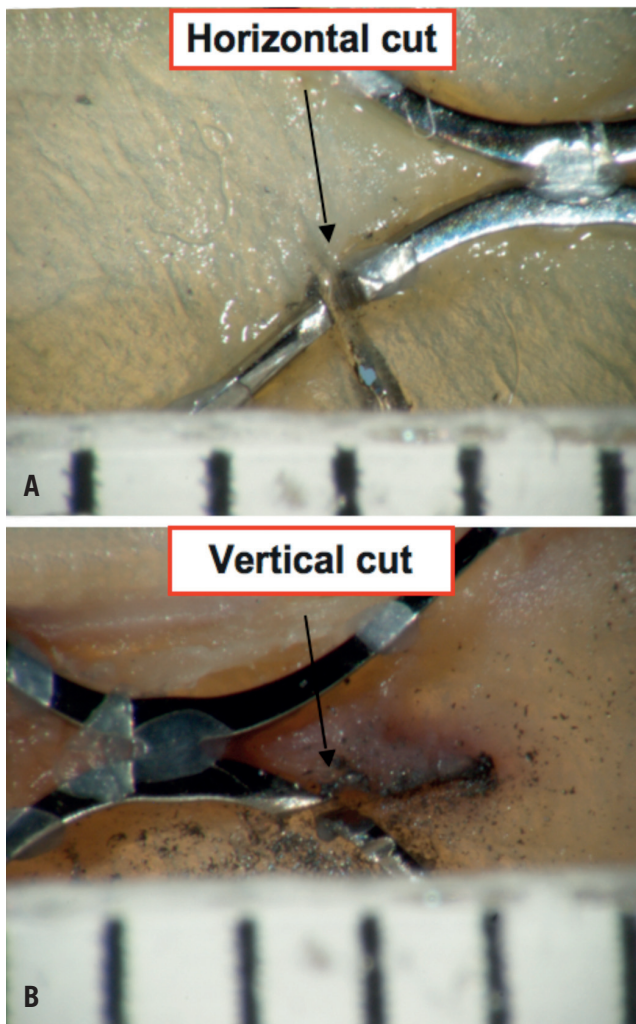
The induced fractures were barely noticeable on gross inspection (Figure 7). Microscopic analysis confirmed the orientation of the fractures in the vertical and horizontal planes (Figure 6). Furthermore, both fractures measured approximately 0.3 mm in width.

Figure 5. Microscopic evaluation (15X) of the frame with the horizontal cut (A) and the frame with the vertical cut (B). In both cases, the cut measured approximately 0.3 mm.

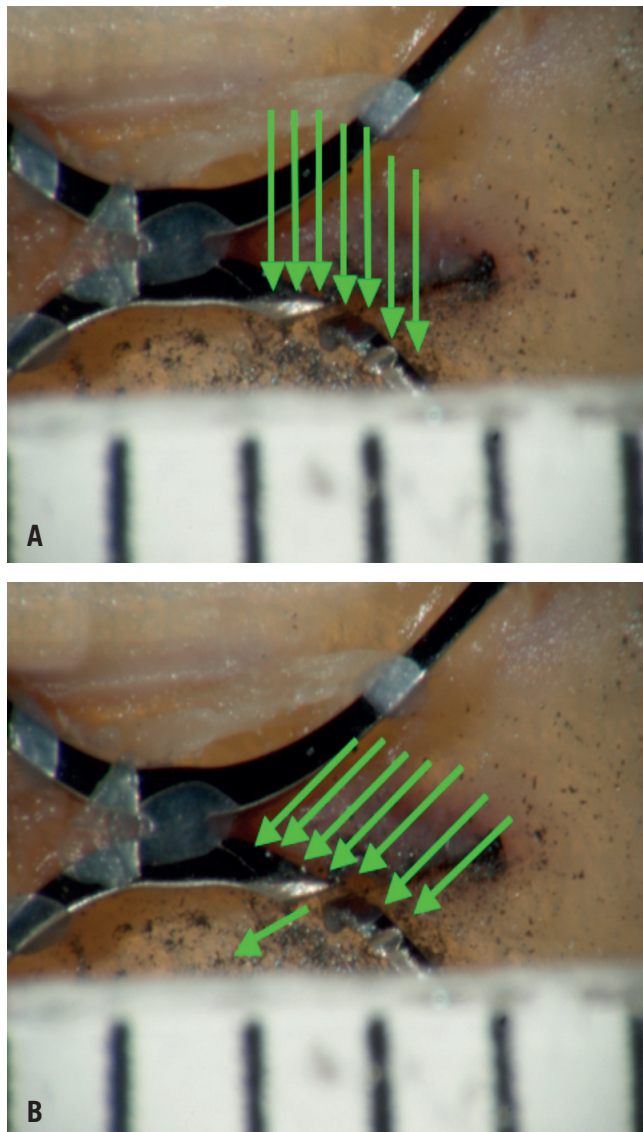
horizontal and in the second prosthesis it was vertical with respect to the long axis of the frame (Figure 5). We hypothesised that the orientation of the fracture plane will have an impact on the visibility of the fracture depending on the gantry-viewing angle (Figure 6). This was another reason why we performed rotational fluoroscopy in both the left-right and cranial-caudal directions.

Figure 6. A. The x-rays (green arrows) in this orientation cannot pass through the cut and therefore would not be detected. B. A change in gantry position allows x-rays to pass through the cut and be detected.

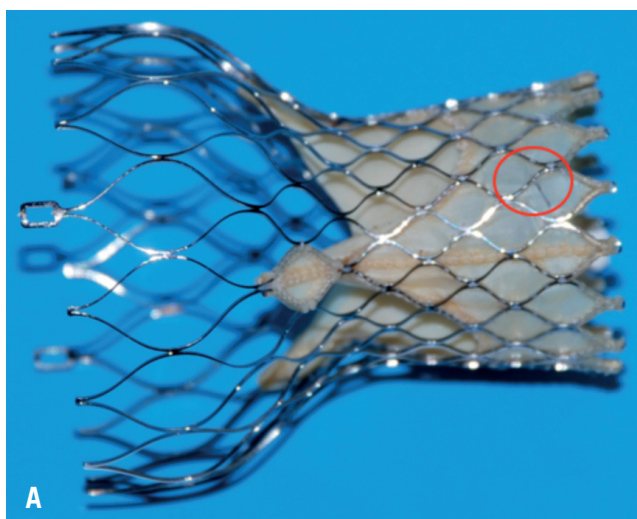
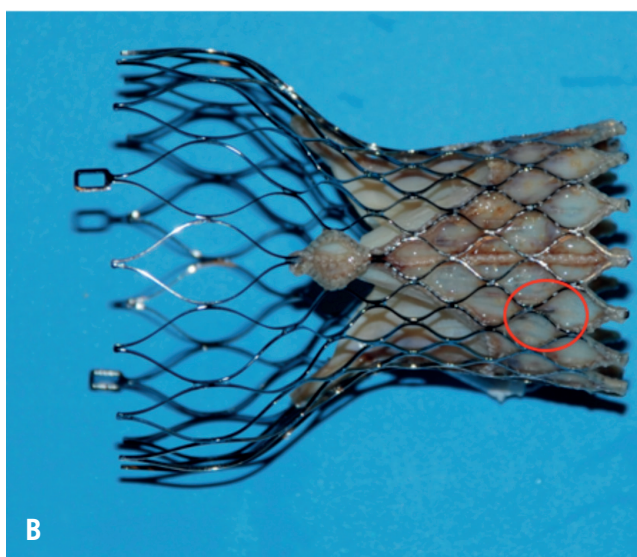
Figure 7. Experimentally-induced fractures (seen microscopically in Figures 5 and 6) are hardly visible by macroscopic inspection.

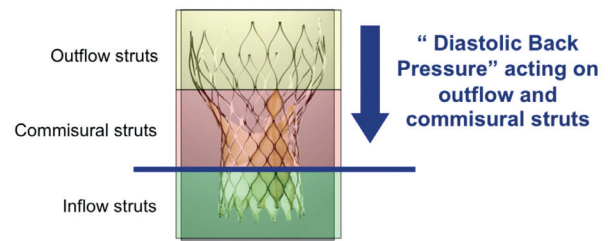
What are the clinical or functional implications of a CoreValve® frame fracture? The answer would be speculative at best and in part, may be related to the site of fracture. A fracture involving the inflow struts would likely have no implications on valve function or durability (Figure 9). On the other hand, a fracture involving the commissural or outflow struts may have an impact on valve function and/or durability as these struts are linked to the prosthetic valve leaflets and absorb the “back pressure” during diastole. Finite element analysis can be used to identify peak strain locations on the frame based on the loading conditions entered into the model.

Figure 9. The cyclic diastolic pressure load is imparted on the commissural and outflow struts. It is possible that a commissural strut fracture would have greater implications for valve function and durability than an inflow strut fracture.
