Delayed fracture of a bioresorbable vascular scaffold implanted for in-stent restenosis

Department of Cardiology, Hospital Universitario de La Princesa, Madrid, Spain

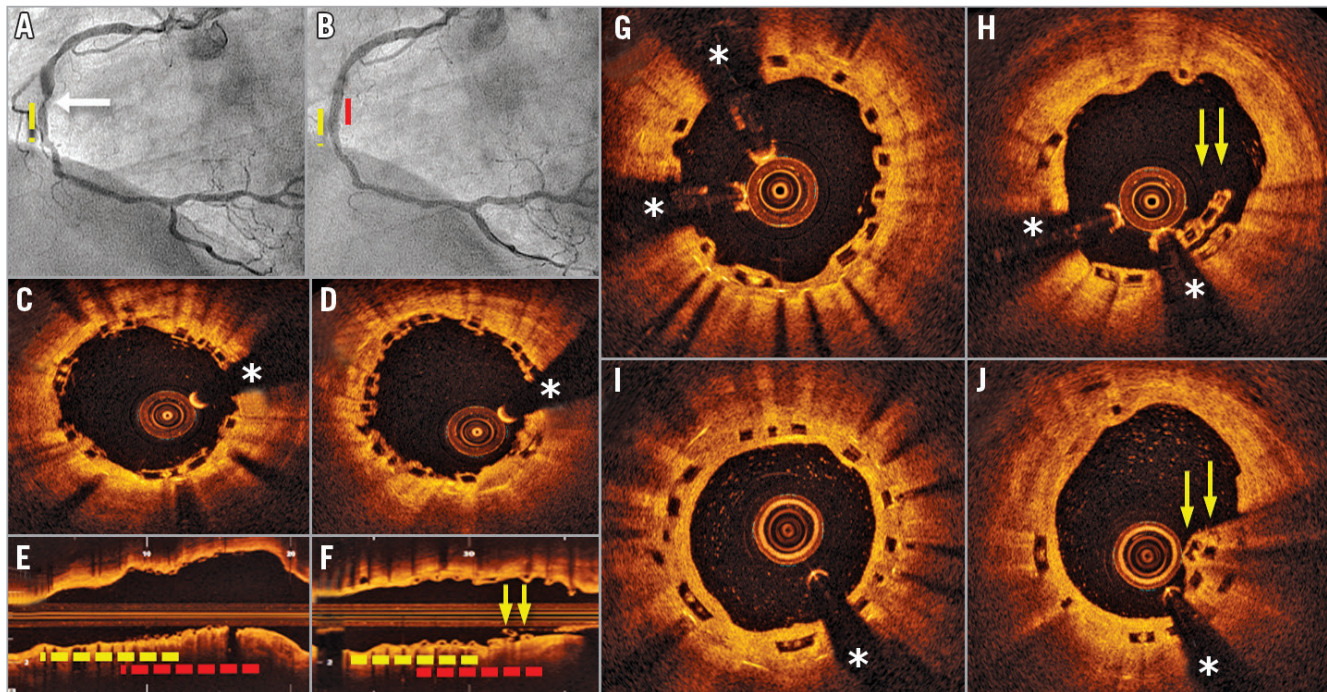
A 61-year-old woman presented with effort angina one year after the implantation of a drug-eluting stent (DES) in the mid right coronary artery (RCA). Coronary angiography revealed a proximal “edge” in-stent restenosis (**Panel A**, arrow; yellow broken line: DES) that was successfully treated with a 3×8 mm bioresorbable vascular scaffold (BVS) (Absorb™; Abbott Vascular, Santa Clara, CA, USA) at 20 bar (**Panel B**, red broken line: BVS). Optical coherence tomography (OCT) confirmed an excellent expansion and apposition of the BVS (**Panel C-Panel E**, yellow broken line: DES; red broken line: BVS). One month later she was admitted for an inferior acute myocardial infarction. Urgent coronary angiography showed a good result of the BVS but complete occlusion of the most distal RCA that was treated with a new DES. On OCT, the BVS was covered by incipient bright neointima. However, a localised malapposition of some BVS struts was readily identified leading to the diagnosis of late scaffold fracture (**Panel F-Panel H**, arrows). No further intervention was made. At eight-month follow-up, the BVS maintained an excellent angiographic result and OCT revealed

complete neointimal coverage of the fractured BVS (**Panel I**, **Panel J**, arrows) (*denotes wire artefact).

Stent fracture is a rare complication described in metallic stents and, more recently, also in BVS. Stent fracture is associated with major complications including restenosis, aneurysm/pseudoaneurysm formation and thrombosis. Risk factors include high implantation pressures and hinge point location. Our BVS was implanted at high pressures but not at a hinge point. The fracture was detected well before the time required for resorption-induced structural BVS disintegrity. Iatrogenic mechanical disruption can never be completely discarded but no clues were identified in this regard. Notably, the BVS rupture was located precisely at the edge of the previous DES. The potential interaction of the rigid underlying DES platform with the flexible overlapping BVS structure should be investigated. To the best of our knowledge, this is the first description of a delayed fracture in a BVS implanted for in-stent restenosis.
