Fracturing mechanics before valve-in-valve therapy of small aortic bioprosthetic heart valves

Peter Johansen¹, PhD; Henrik Engholt¹, MSc; Mariann Tang², MD, PhD; Rasmus F. Nybo¹, MSc; Per D. Rasmussen¹, MSc; Jens Erik Nielsen-Kudsk^{3*}, MD, PhD, DMSc

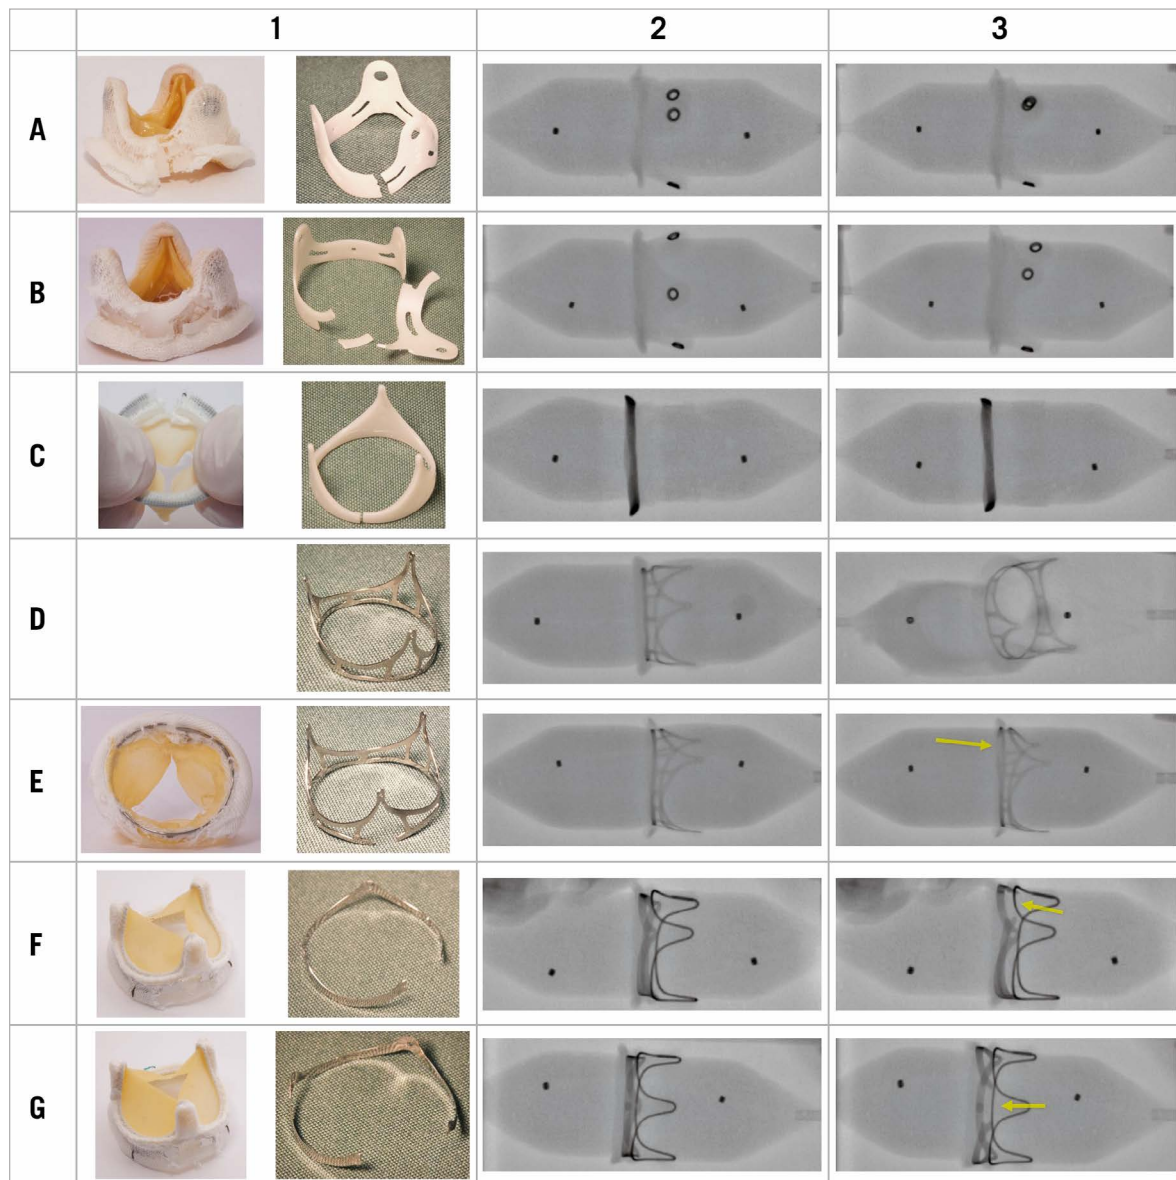
The fracture results are summarised in **Table 1** and **Figure 2**. **Table 1** shows that the fracture pressures for the Mosaic valves (19 mm and 21 mm) and the Mitroflow 21 mm valve were in a similar range (8-10 atm). Even though the frame in the Mosaic 19 mm fractured (**Figure 2A1**), the sutures holding the tissue to the sewing ring were intact. The Mosaic 21 mm demonstrated three fractures at 8, 10, and 12 atm, respectively. This was verified after dissection where the acetal homopolymer stent had

three fracture zones (**Figure 2B1**). A single fracture in the polymer frame was observed in the Mitroflow 21 mm, which was confirmed by inspection after dissection (**Figure 2C1**). The Trifecta, however, demonstrated much higher resistance to fracture. It was not possible to fracture the Trifecta 19 mm. Instead, the Atlas

GOLD balloon burst at 30 atm, which is well beyond the manufacturer's rated burst pressure of 16 atm. Even though fracture was not possible, the metal frame did experience notable deformation (**Figure 2D1**). The Trifecta 21 mm did fracture but at a high pressure of 26 atm. A single fracture of the metal stent was observed

Figure 2. Valve fracture images. Column 1. Images of the valves after the fracture procedure. Left: The fractured valve where the sewing cuff material has been incised to expose the underlying fractured frame structure. Right: The excised valvular frame structure. Columns 2+3. Fluoroscopy images of the valves on the balloon before (column 2) and after (column 3) the fracture procedure. Row A: Mosaic 19 mm; row B: Mosaic 21 mm; row C: Mitroflow 21 mm; row D: Trifecta 19 mm; row E: Trifecta 21 mm; row F: Magna Ease 19 mm; row G: Magna Ease 21 mm. Notice that the balloon has ruptured in image D3 with the non-fractured Trifecta 19 mm.

and confirmed (**Figure 2E1**, where the fracture is seen at the top of the valve image). The Magna Ease valves (19 mm and 21 mm) both having metal frames were possible to fracture. However, the fracture pressure was 19-21 atm which is about twice the pressure needed to fracture the polymer frames. For the Magna Ease valves, a single fracture was observed in the metal frame (**Figure 2F1**, **Figure 2G1**).

Fluoroscopy always demonstrated a clear indentation in the balloon prior to fracture (**Figure 2**, column 2). Post fracture, the

balloon shape even appeared with no or very little indentation (**Figure 2**, column 3). The fracture zone of the frame structure was difficult to identify on the polymer frame valves, but for the fractured metal frame valves (Trifecta 21 mm and the two Magna Ease valves) it was visible, most notably for the Magna Ease valves (fractures indicated by an arrow in **Figure 2**).
