Stent longitudinal distortion: strut separation (pseudo-fracture) and strut compression (“concertina” effect)

Antonio L. Bartorelli^{1,2*}, MD; Daniele Andreini¹, MD; Gianluca Pontone¹, MD; Daniela Trabattoni¹, MD; Cristina Ferrari¹, MD; Saima Mushtaq¹, MD; John A. Ormiston³, MBChB

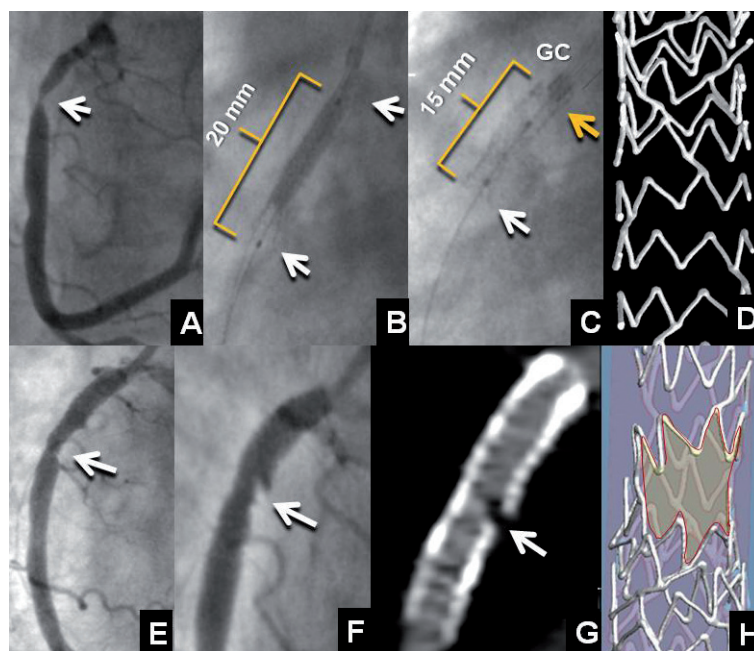
Figure 1. Baseline angiography (A) revealed a severe proximal RCA stenosis (arrow). At deployment (B), the Promus Element stent measured 20 mm in length and shortened by 5 mm after deployment (C). A likely explanation is that the winged deployment balloon caught the distal end of the stent (white arrow) pulling hoops together and simultaneously pulled the guide catheter (GC) onto the proximal stent end pushing hoops together. Note the increased radiopacity of the proximal end of the stent due to multiple strut crowding (yellow arrow). To assist in understanding these phenomena, frame D shows a micro-computed tomography of a Promus Element stent that has been shortened in a phantom by proximal hoops being pushed together by the guiding catheter. This image also shows the Element platform design (zigzag out-of-phase hoops with two angled connectors per hoop joining off-set peaks) conceived for flexibility and deliverability improvement. Frame E shows residual stenosis exposed by stent shortening. After deployment of an additional Promus Element stent and multiple post-dilatations with a non-compliant balloon, strut separation with thrombus and plaque prolapse was observed by invasive (F) and CT angiography (G). Frame H is a micro-computed tomography of a Promus Element stent that has been damaged in a mock artery by the distal tip of a non-compliant balloon pushing hoops apart and causing a pseudo-fracture.

balloon catching on the distal stent on withdrawal associated with deep guide catheter intubation. Stent shortening uncovered part of the lesion that was treated with an additional 4.0×8 mm stent of the same design. The post dilation non-compliant balloon pushed struts apart which appeared on CT angiography as stent discontinuity that could have been misinterpreted as strut fracture. This was associated with an intraluminal filling defect, presumably prolapsing plaque and thrombus. The disrupted stent was treated by implantation of a third stent (4.0×8.0 mm XIENCE PRIME; Abbott Vascular,

Santa Clara, CA, USA) with a good angiographic result. The patient remains well at 8-month follow-up.

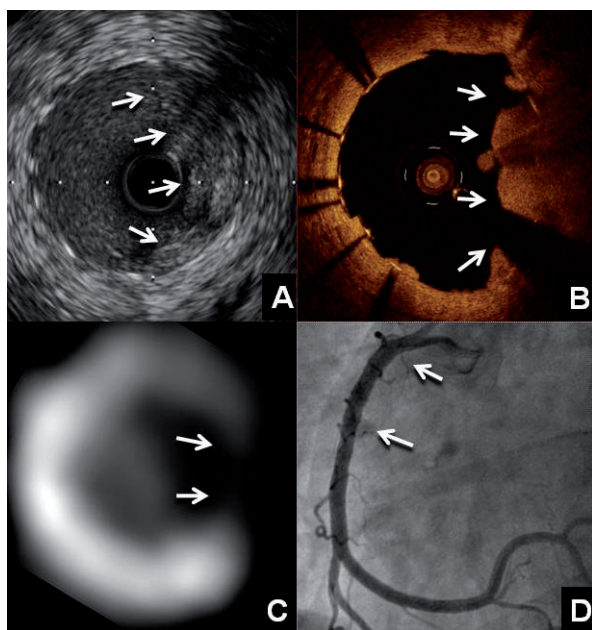
Figure 2. Intravascular ultrasound (A) showed plaque prolapse (arrows) at a region without stent struts from 12 o'clock to 6 o'clock. Optical coherence tomography (B) of the same region confirmed the 180° absence of stent struts, also demonstrated by the short-axis CT image (C), and a large thrombus adhering to the prolapsing plaque (arrows). Final angiography (D) showed a widely patent vessel (arrows) after implantation of another drug-eluting stent to the disrupted site.

Our patient demonstrated stent longitudinal distortion with stent compression and strut separation. Additional stenting was required to treat a stenosis that was uncovered by stent shortening, then further stenting was needed for strut separation that had caused plaque prolapse and thrombus formation. Stent design involves trade-offs, and improvement in flexibility and deliverability achieved by modifying connector numbers and configuration can be at the expense of longitudinal integrity⁴.
