A clinical protocol for analysis of the structural integrity of the Medtronic CoreValve System® frame and its application in patients with 1-year minimum follow-up

Abstract

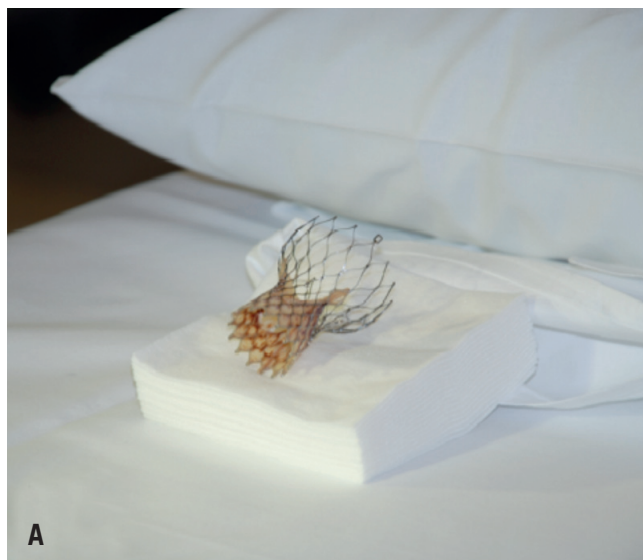
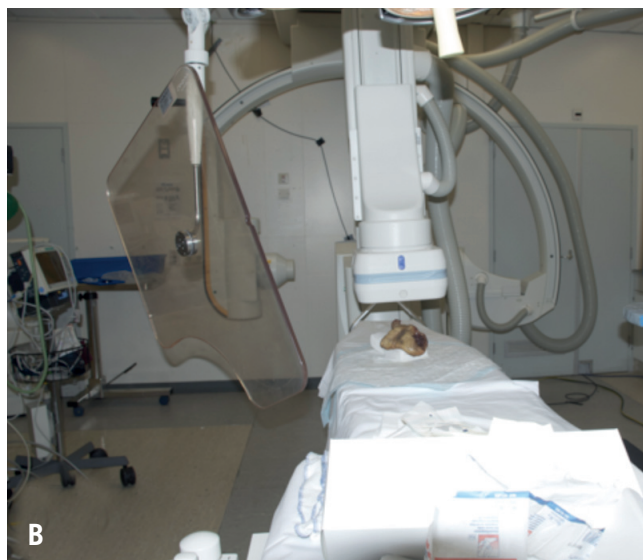
Figure 1. A. Fluoroscopic imaging of “bare” CoreValve® prosthesis. B. Fluoroscopic imaging of CoreValve® prosthesis after orthotopic implantation into post-mortem heart.

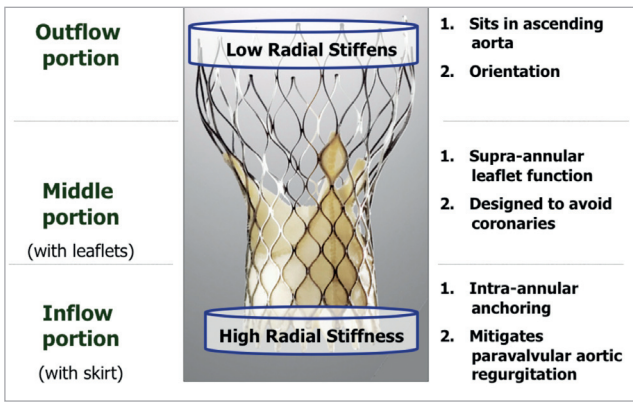
The CoreValve® bioprosthetic heart valve consists of a nitinol frame and was designed with three distinct regions (Figure 2). The inflow portion has high radial stiffness and functions to anchor the valve against the left ventricular outflow tract and native aortic valve leaflets. The middle portion, where the prosthetic leaflets reside, is waisted to resist deformation and maintain leaflet geometry and maintain coronary perfusion. The outflow portion, which sits in the ascending aorta, has low radial stiffness and orients the prosthesis axial to the aortic root.

Figure 2. The inflow portion has high radial stiffness and functions to anchor the valve against the left ventricular outflow tract and native aortic valve leaflets. The middle portion, where the prosthetic leaflets reside, is waisted to resist deformation and maintain leaflet geometry and maintain coronary perfusion. The outflow portion, which sits in the ascending aorta, has low radial stiffness and orients the prosthesis axial to the aortic root.

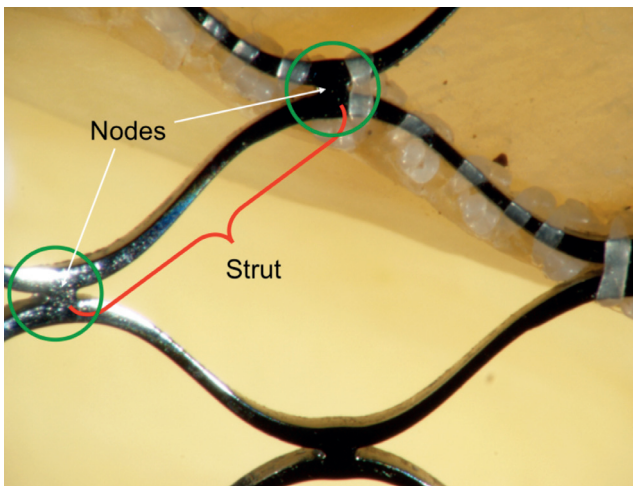
A fracture was defined as a discontinuity in the appearance of a *strut* of the CoreValve® frame. A strut is bordered at its two ends by *nodes*

Figure 3. The red parenthesis represents a strut of the frame. The strut is bordered at its ends by nodes (green circle).

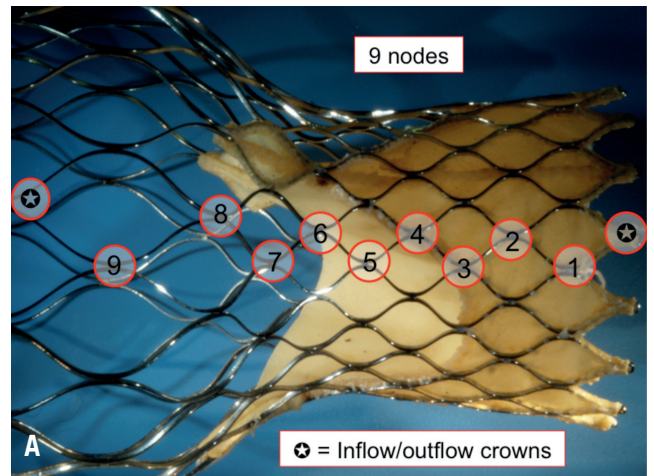
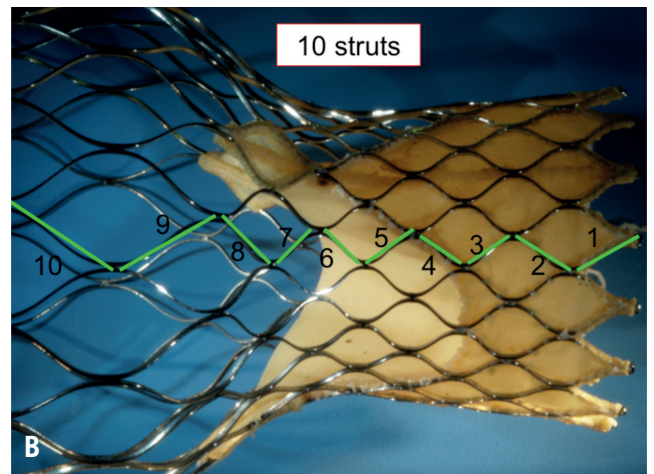
(Figure 3). There are nine nodes and 10 struts across the total frame of the CoreValve® bioprosthesis (Figure 4). Based on their location within the tri-level frame design, struts were further classified as follows: struts 1-3 as inflow struts, 4-8 as commissural struts, and 9-10 as outflow struts. In addition to being useful to communicate fracture location, this classification can be used to discuss potential clinical and/or functional implications of strut fractures.

Figure 4 A. There are a total of nine nodes across the length of the frame. Either end of the frame consists of a half diamond – known as the inflow and outflow crown B. There are a total of 10 struts across the length of the frame.

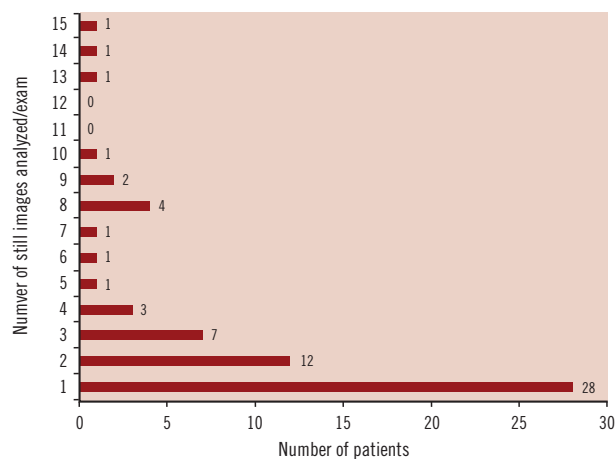
The mean and median follow-up times were 22 months and 24 months, respectively (range 12 to 36 months). Subjective image quality was graded as “good” in 31 assessments, “fair” in 30, and “poor” in two. All films were stored and analysed with a resolution of 512x512 pixels. The recorded frame rate ranged from 10 to 30 frames/sec (10 frames/sec n = 11 assessments, 12.5 frames/sec n = 9 assessments, 15 frames/sec n = 24 assessments, 25 frames/sec n = 2 assessments, 30 frames/sec n = 16 assessments, not available n = 1 assessment). The number of still images per assessment available for analysis ranged from 1 to 15 (Figure 8). In addition to the still images, rotational films (only left-right lateral) were available in 39 patients (60%).

Figure 8. The majority of patients (n=40) had one or two still images available for analysis.
