## To nurture a snake in one's bosom: aspiration of a giant right atrium thrombus after a MitraClip procedure

Jean-Michel Paradis\*, MD; Kim O'Connor, MD; Luis Asmarats, MD; Josep Rodés-Cabau, MD

Department of Cardiology, Quebec Heart and Lung Institute, Quebec City, Quebec, Canada

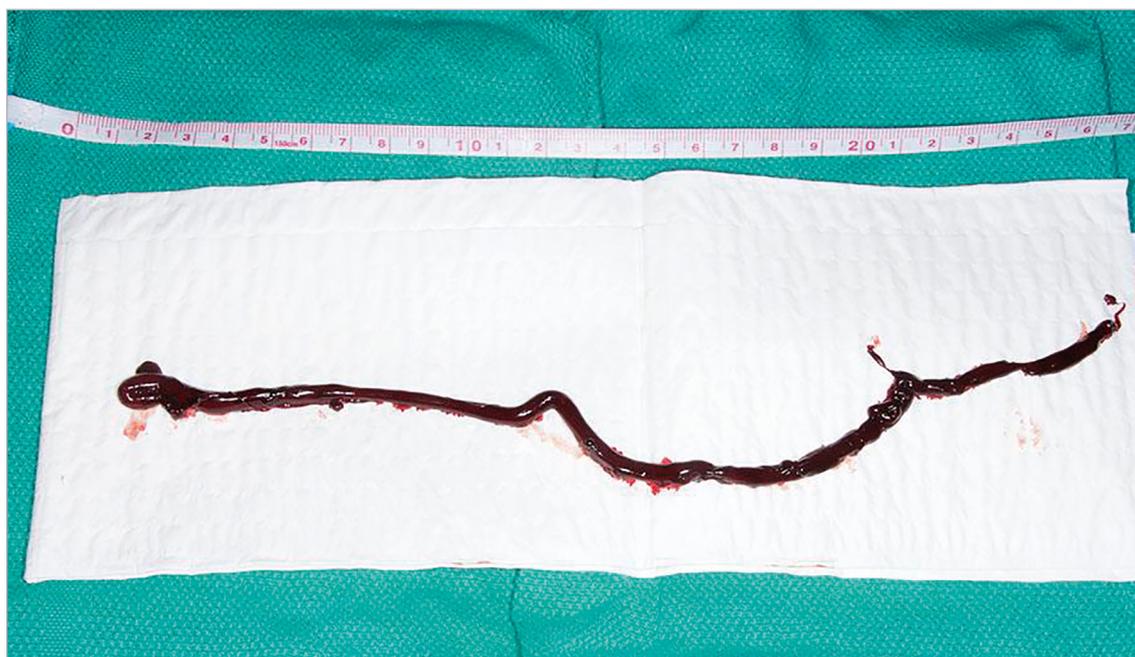
**Figure 1.** Picture of the catheter-related thrombus (measuring at least 27 cm), which remained almost completely intact despite the aspiration process.

A 90-year-old man, with a past medical history significant for type 2 diabetes mellitus, atrial fibrillation, chronic lymphocytic leukaemia, and prior sutureless aortic valve replacement with a Perceval valve (Sorin Group, Saluggia, Italy), was admitted to our institution because of decompensated heart failure caused by severe degenerative mitral regurgitation (MR). The Heart Team deemed the patient to be at very high risk for a reoperative open heart surgery. Hence, he was referred for a MitraClip® (Abbott Vascular, Santa Clara, CA, USA) procedure. The MR was significantly reduced after the deployment of one clip. The 24 Fr steerable guide catheter was thus removed from the right femoral vein. Despite appropriate flushing of the guide catheter and adequate anticoagulation with intravenous heparin during the entire MitraClip procedure (ACT >250 sec), a giant, very mobile, moulding thrombus of the steerable guide catheter was seen in the right atrium on transoesophageal echocardiography (**Moving image 1**). Through a long 14 Fr sheath placed in the left femoral vein, we were able to aspirate the 27 cm catheter-related “snake-like” thrombus completely (**Figure 1**). The patient was rapidly extubated. A ventilation perfusion scan did not reveal any signs of pulmonary embolism. The patient was put on IV heparin after the procedure and then bridged to Coumadin. He was discharged home three days later. Thrombi forming within large catheters used for structural heart interventions are usually multicausal, can have

catastrophic consequences and should be avoided by constantly flushing the catheters as well as by aiming for a very high level of anticoagulation during the procedure. The optimal treatment remains controversial, including anticoagulation, thrombolysis, surgical thrombectomy and percutaneous thromboaspiration<sup>1</sup>.
